Subject: **WATER RESOURCE INVENTORY REPORT**
1284 Highway 96
(Parcel #'s 018 04801 0001018; 018 04801 00001018)
Fairview, Williamson County, Tennessee
C&T Project No. 03-25058
RSMG Project No.: E25-036

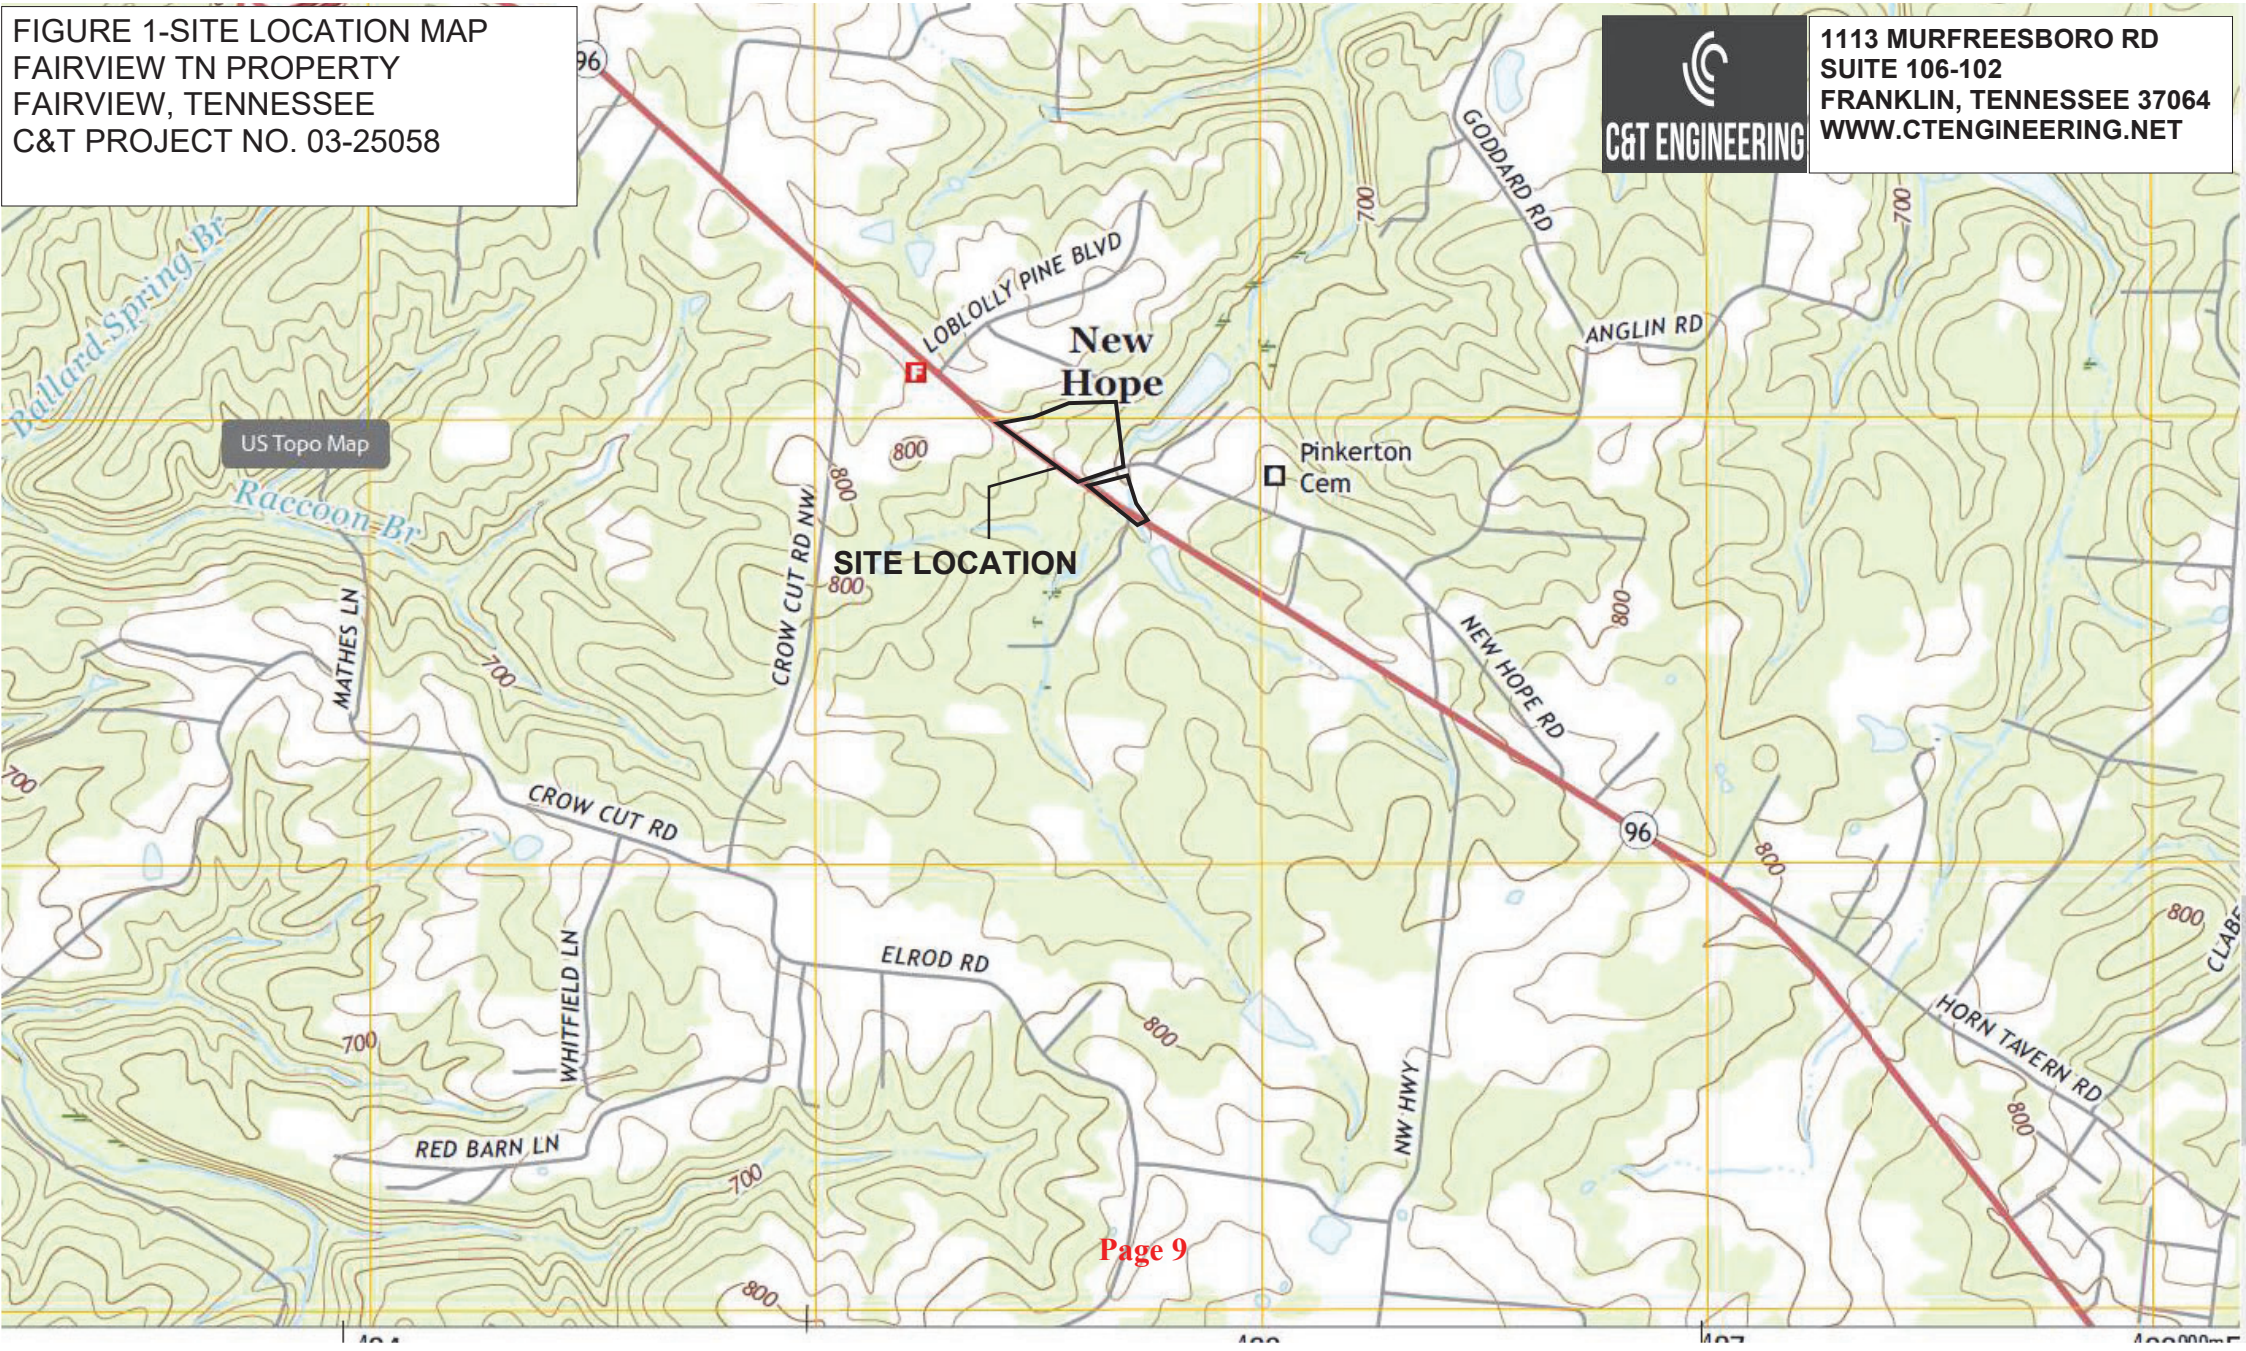
FIGURE 1-SITE LOCATION MAP
FAIRVIEW TN PROPERTY
FAIRVIEW, TENNESSEE
C&T PROJECT NO. 03-25058

The site is located on the White Bluff, Tennessee US Geological Survey 7.5 Minute Topographic Quadrangle dated 2016 and the elevation of the property ranged from 710 feet above mean sea level near southeastern property corner to 770 feet above mean sea level along northern property boundary. (**Figure 1**).
